Journal of Environmental Science and Pollution Research

Bio-Deterioration and Scientific Preservation of Queen's Mosque

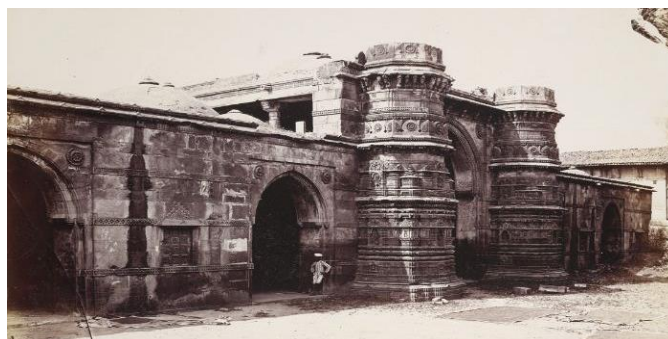
Fig. 1 Front view of Queen's Mosque showing fungal growth on the surface

The Queen's Mosque is made of sandstone, which is porous in nature. The mosque appears very old due to the formation of secondary pale greenish white lichen deposits on the surface of the mosque built of stone. The beauty of the mosque has been seriously affected due to these fungal deposits. From the scientific point of view, this fungal deposit is very harmful for the health of the stone surface, as these microbes secrete an acid which dissolves the sandstone. Not only this, the excreta of bats or other birds on the stones is also causing damage to the surface of the mosque because the chemicals found in the excreta of bats and other birds react chemically with the components of the stones and erode them. In such a situation, scientific conservation of the mosque is very important. But before starting the conservation process, it is necessary to examine the factors causing the problem.

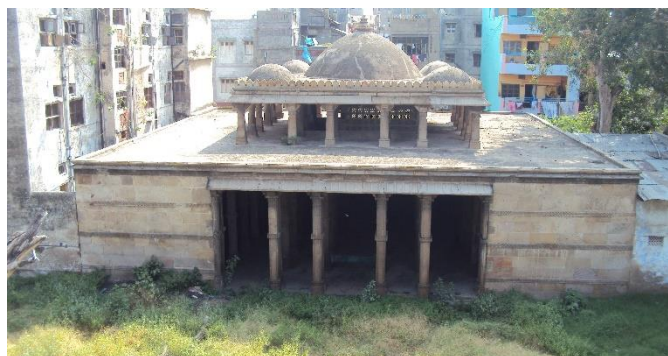
Fig. 2 Showing different Pillars inside the Mosque

Queen's Mosque (Figs. 1 and 2) in Sarangpur was built by Malik Qiwam 'ul-Mulk Sarang. He was a Rajput converted to Islam under the influence of the Sultan and later rose to the status of the Governor of Ahmadabad, in AD 1521, during the reign of Muzaffar Shah II. The Masjid probably built during the second half of the fifteenth century measures 14.56 meters by 11.13 meters on the inside and has five large domes over as many square areas in the sanctuary, entered into through fine arched gateways, the central one being large, higher and with a richly carved arch-rim; The two large-sized minars standing on either side of the centre or now unfortunately extant up to the roof only, resemble closely those of Bibi-Ki-Masjid of Rajpur. The front wall behind the minars is raised on the central portion to about 2.74 meters along a stretch of 12.80 meters but on the interior, there is only a kind of balcony to the gallery resting on pillars of normal height. This is further connected with the gallery under the central dome. The front wall has four perforated windows while on the back wall there are six, with two at the each of side walls [1].
